## History and Geomorphology of Fletcher Slough and Lower Joe Culvert Creek, 1906 through 2002

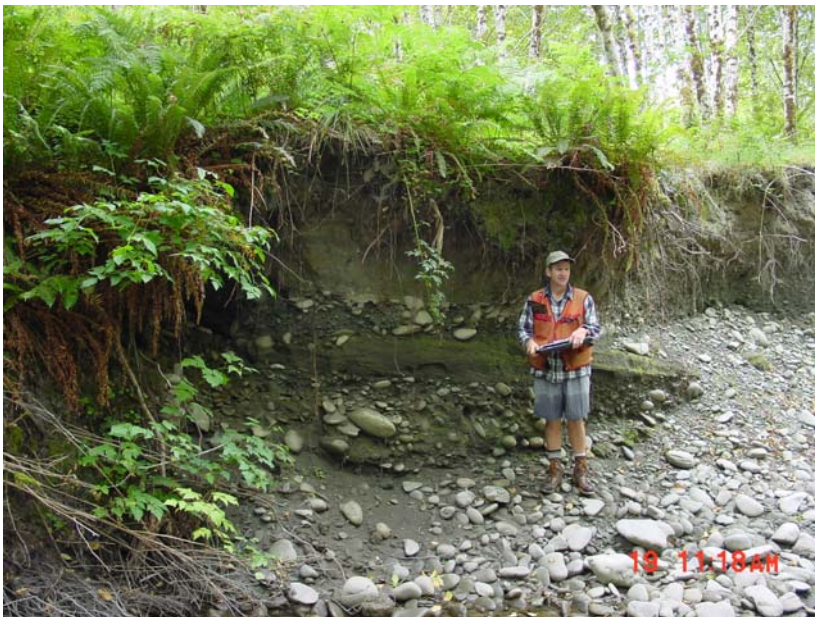
Figure 2. Bank exposure along one of the terrace channels on the south side of the Quinault River between RK 10.5 and RK 15.4. Note the depth of the incision and the alternating gravelly channel deposits and fine-grained floodplain deposits exposed in the bank. Photograph taken by J.Bountry (Bureau of Reclamation, Denver, 2004).
